**CPR Part 35 Expert Report
by SJM Butler, MRICS**

**Leaking Roof/ Chimney Junction
Daventry Street**

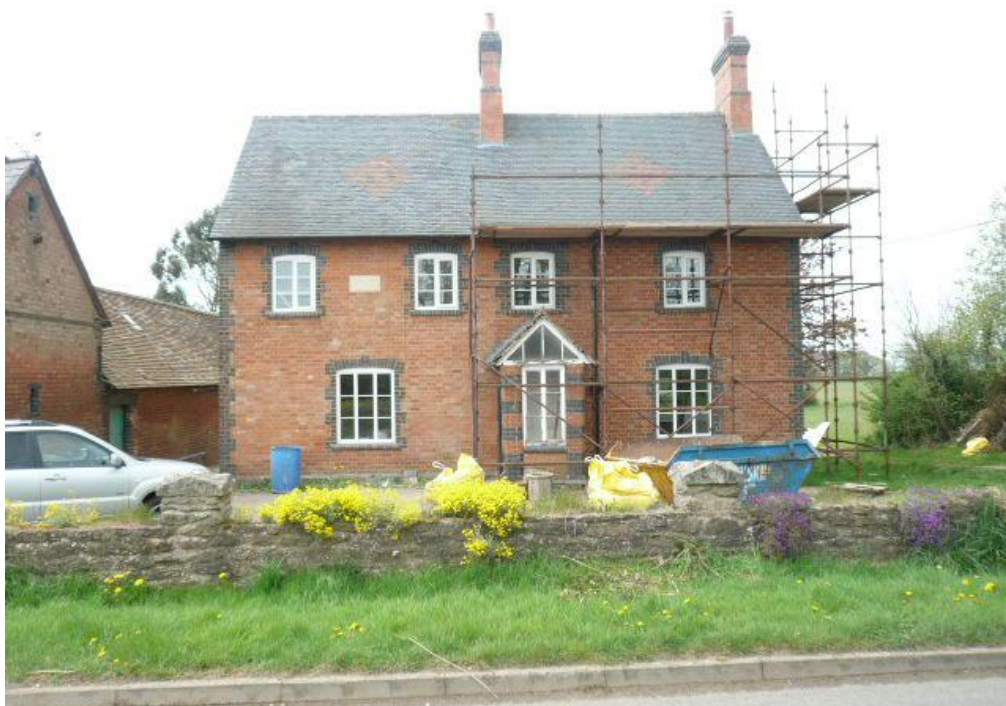
- 3.1 The property is detached Victorian house and outbuildings at Daventry Steet . It fronts the Daventry Street in otherwise open countryside and is very exposed to winds from the south west. A general view of the property is shown by Photograph 1.

Photograph 1: General View of Daventry Steet

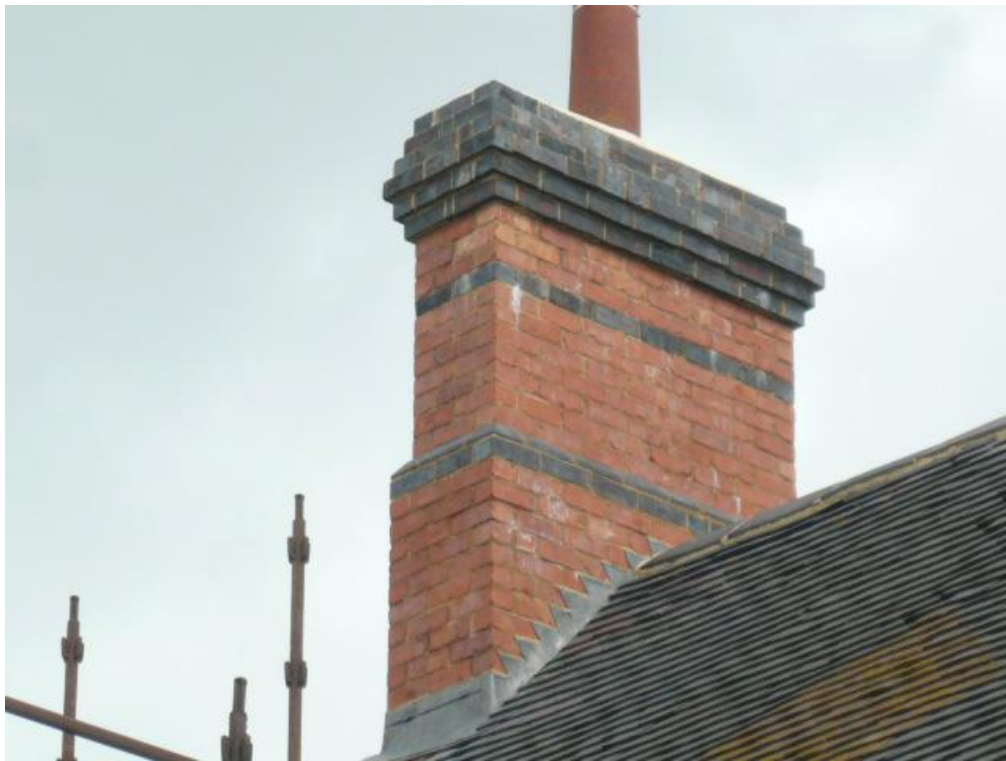
- 4.5 The exterior of the chimney at the northern end of the roof weather proofing and adjacent tiles could only be inspected from ground level with binoculars. No deficiencies were apparent. Photograph 2

Photograph 2: The northern chimney viewed from the South West.

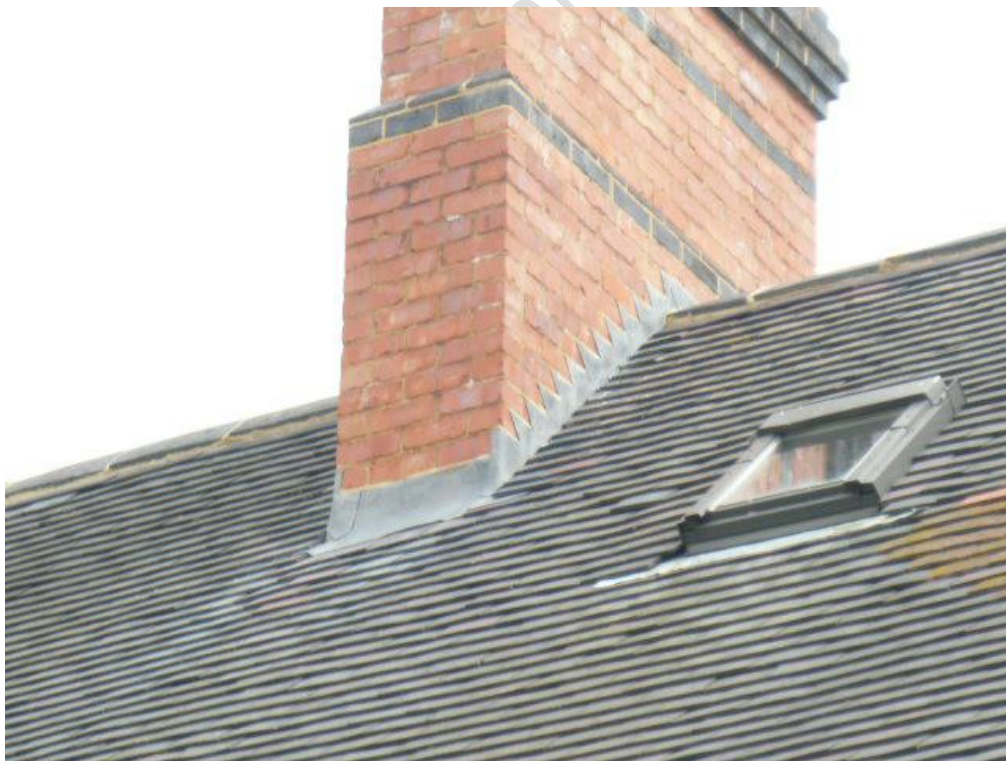
Photograph 3: The central chimney viewed from the South West

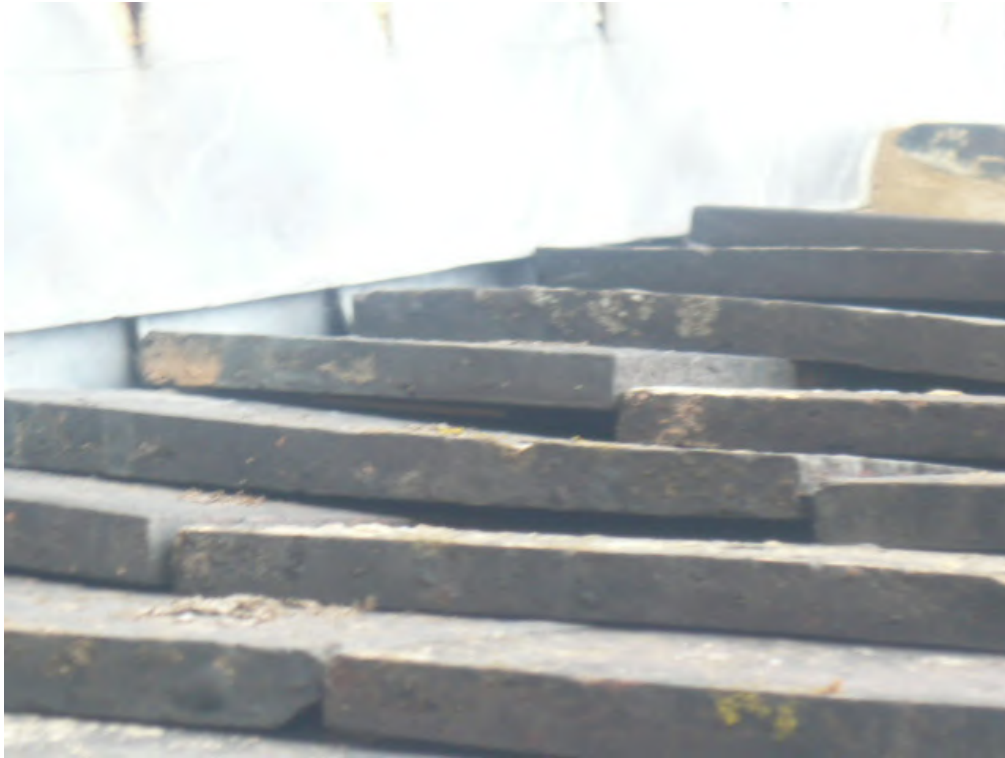
- 4.6 The south west side of the central chimney could be inspected from a nearby roof light that is in close proximity. Photographs 3. It was noted that two of tiles close to the chimney do not sit correctly. They rest on adjacent tiles so that that there are small gaps at the sides of the tiles under which water might be blown in extreme conditions. No other deficiencies were apparent. Photograph 4

Photograph 4: Tiles adjacent to the central chimney that are not sitting correctly viewed from the South West.

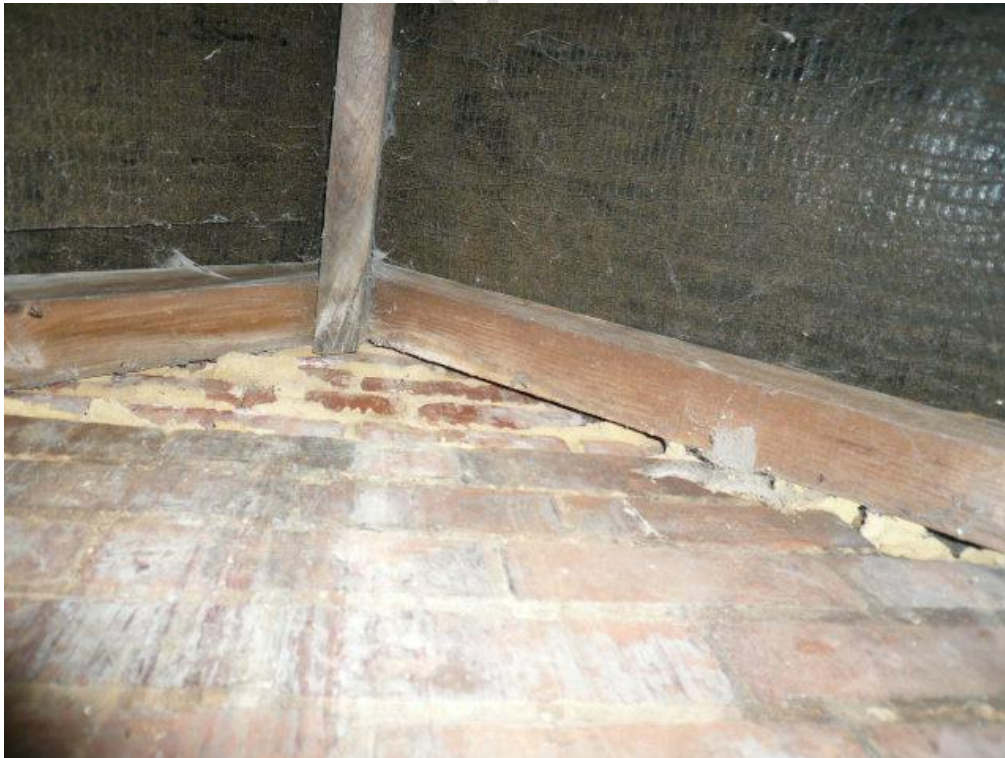
- 4.7 The other sides of the central chimney could only be inspected from ground level with binoculars. No deficiencies were apparent.
- 4.8 Inside the roof void the abutment of the northern chimney to the roof covering are obstructed by rafters and the junctures cannot be seen. The lining sheet on the underside of the tiles passes on top over the rafters adjacent to the chimneys, but exactly how it terminates adjacent to the chimney cannot be seen. Photograph 5.

Photograph 5 The face of the North Chimney

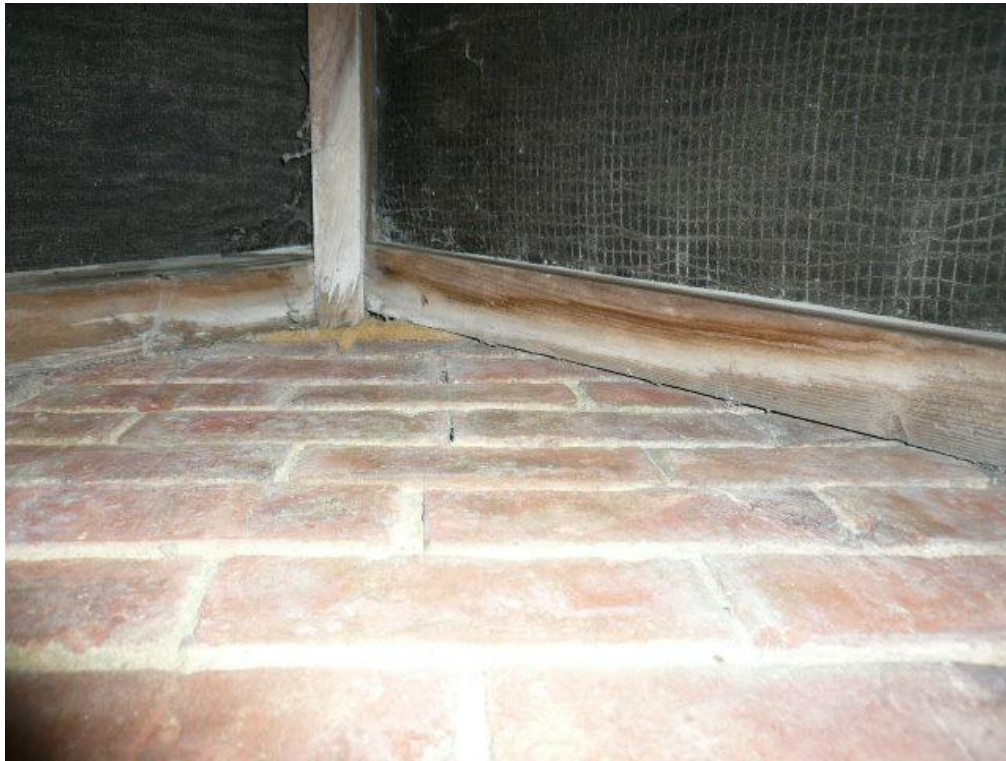
- 4.9 The abutment of the northern side of the central chimney to the roof surface is also obstructed by rafters and the junctures cannot be seen. The lining sheet on the underside of the tiles passes on top over the rafters adjacent to the chimneys, but exactly how it terminates adjacent to the chimney cannot be seen. Photograph 6.

Photograph 6 The northern face of the central chimney

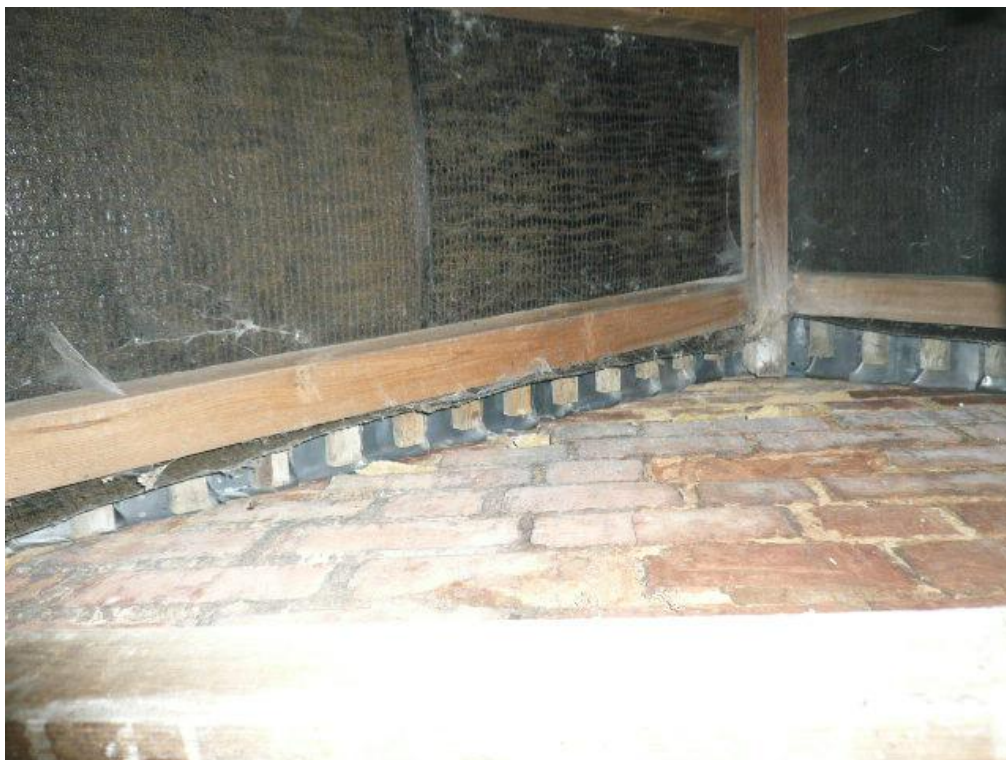
- 4.10 The nearest rafter to the southern side of the central chimney is some distance away from the face of the chimney. The lining sheet has not been secured to the side of the chimney and hangs down the nearest side of the rafter to the face of the chimney. Photograph 7

- 4.11 The failure to secure the lining to the face of the chimney is substandard. It is usual to turn the edge of the lining up against the face of the chimney and secure it by trapping it in place with the metal weather proofing. The continuation of the lining is important on roofs that are in exposed locations as it reduces the wind blowing through the roof and thus its ability to carry moisture or snow through any gaps in the slates. It also as a secondary function catches any moisture or snow that might succeed in entering through the tiles.

5.1 In the absence of any other defects it is considered that the failure to secure the lining sheet to the southern face of the central chimney stack is the cause of the snow and water ingress in extreme conditions.

Photograph 7 The southern face of the central chimney

5.3 In order to remedy the problem the lining sheets secured to the faces of the chimney stacks.
