**CPR Part 35 Expert Report
by SJM Butler, MRICS**

Dispute in respect of dampness at Avenue, Chesterfield,

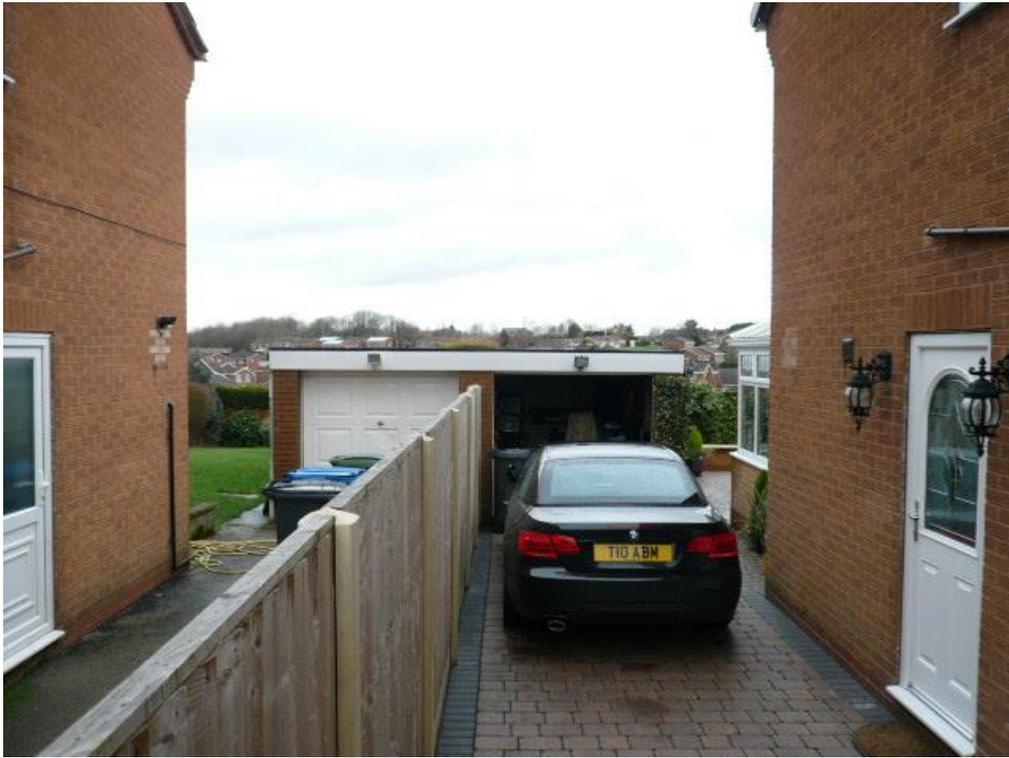
Photograph 1 – Ground levels at 15 and 17 Avenue.

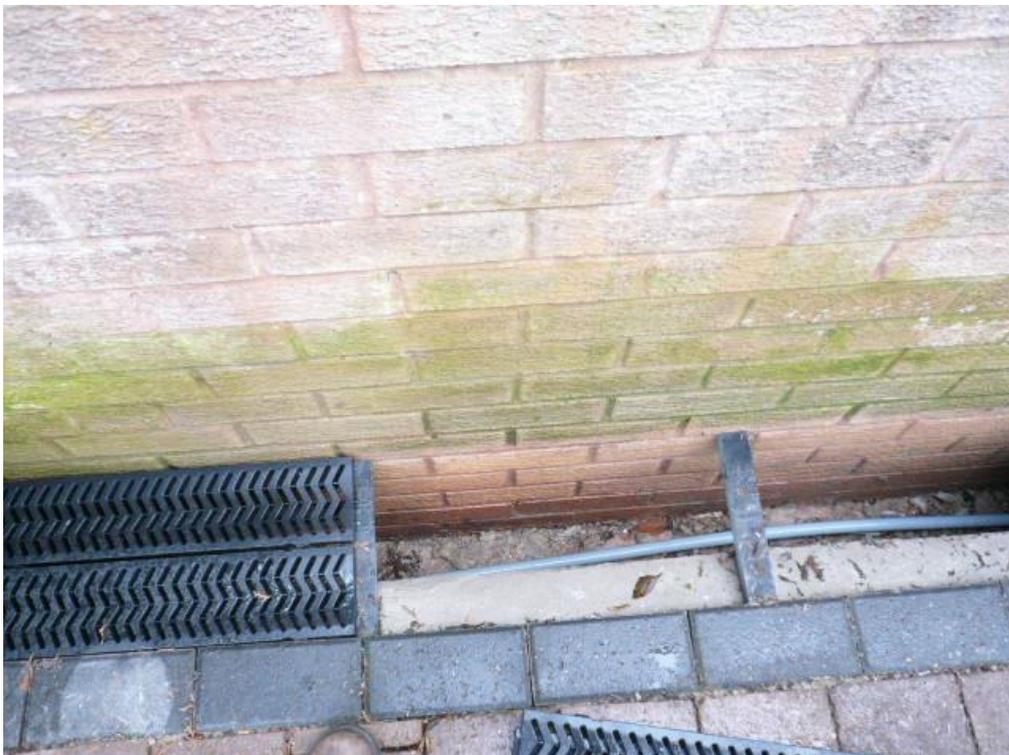
- 4.1 The properties was inspected at lunchtime of 27th January 2014
- 4.2 Inspection of the rear gardens at the rear of 15 and 17 Avenue suggests that the rear gardens are constructed at the natural ground level or as left by the developer when constructed in about 1980. A photograph of the properties is attached as Appendix 1. The patio at 17 Avenue is apart from drainage contours approximately flat.
- 4.3 Inspection of the outer face of the wall of the garage at 19 Avenue that is adjacent to the boundary with number 17 revealed:
 1. The garage at 19 Avenue has been constructed below the natural ground level of 15 and 17 Avenue.
 2. There is an approximately 300mm wide trench between the block paved patio and flowerbed, and line of the boundary to Number 19. A dwarf wall projects into the trench but does not touch the wall of the garage at 19 Avenue. Photographs 2 and 3.

3. That the trench is 150mm deeper than the plastic damp proof course of the garage at 19 Avenue. The trench cannot be any deeper without destroying what appears to be the foundation of the garage at 19 Avenue.

4. That that base of the trench is lower than the floor slab and damp proof course of the garage was also proved by measurement.
5. A block paved patio that has been constructed in the grounds of 17 Avenue has been sloped to ensure that water drains away from the boundary with 19 Avenue.

Photograph 2 – The trench adjacent to the block paved patio at 17 Avenue. Also shows that there has been no damage to the brickwork of 19 Avenue. Base of trench is below floor slab of garage at 19 Avenue.

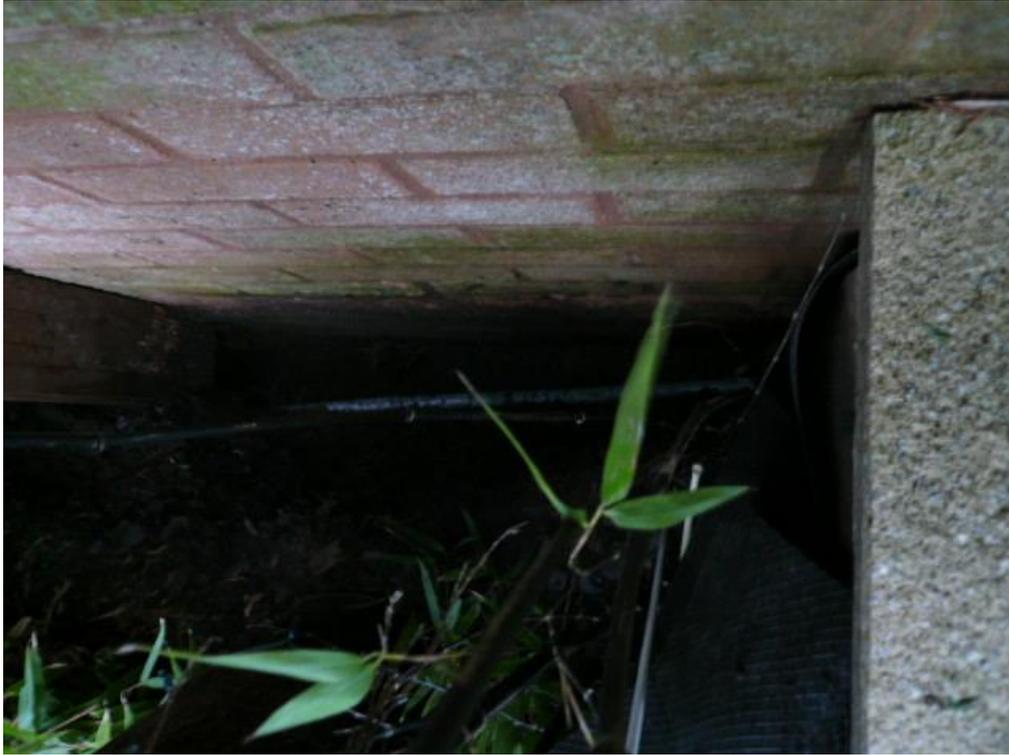
Photograph 3 – The trench adjacent to the flower bed at 17 Avenue. Measurement proved it to be lower than the damp proof course and slab of the garage at 19 Avenue. There is no evidence of damage to the brickwork of the garage. Note the gap at the end of the dwarf wall.

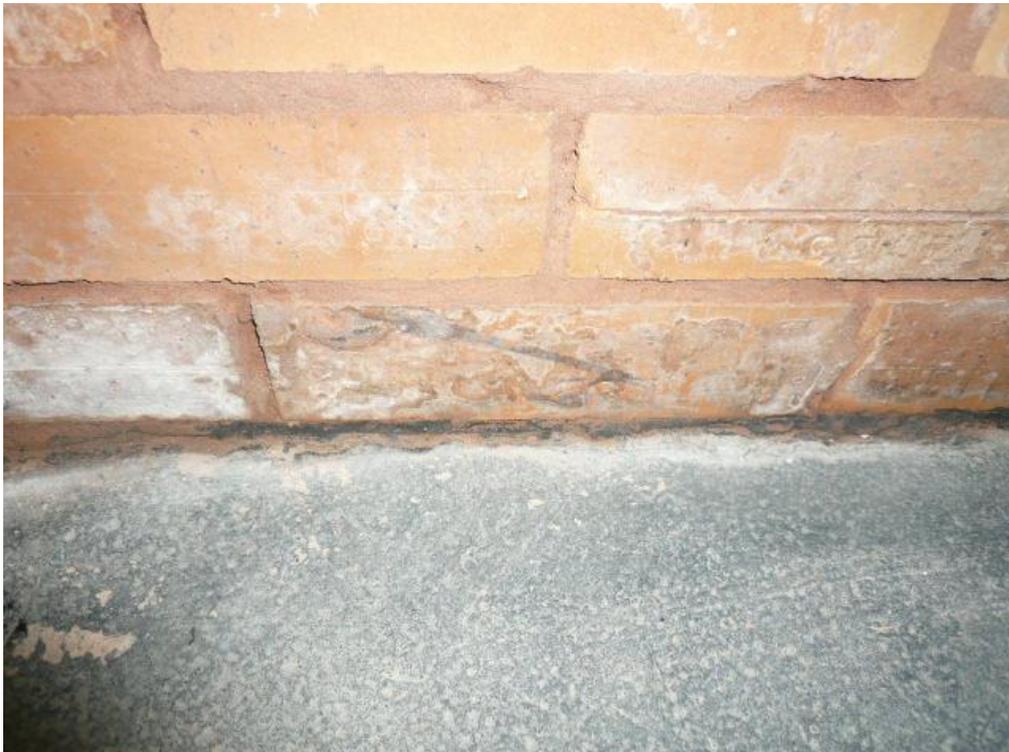
1. That the plastic damp poof course that can be seen to be 150mm above the base of the trench at 17 Avenue is level with the surface of the floor in the garage. Photograph 4
2. The wall abutting the boundary is in a condition typical of its type and age. There is no erosion of the pointing consistent with a damp wall having been exposed to frost over a long period. Photograph 5.
3. A small area of paint that has been applied to the surface of the garage floor has eroded. There is no evidence to link this to dampness of the wall. There are many other potential possible causes. Photograph 5.
4. That the garage is very full with stored materials which could increase the risk of condensation due to the stored materials preventing proper ventilation.

Photograph – 4 The plastic damp proof course of the garage at 19 Avenue the outer edge of which is 150mm above the level of the trench at 17 Avenue.

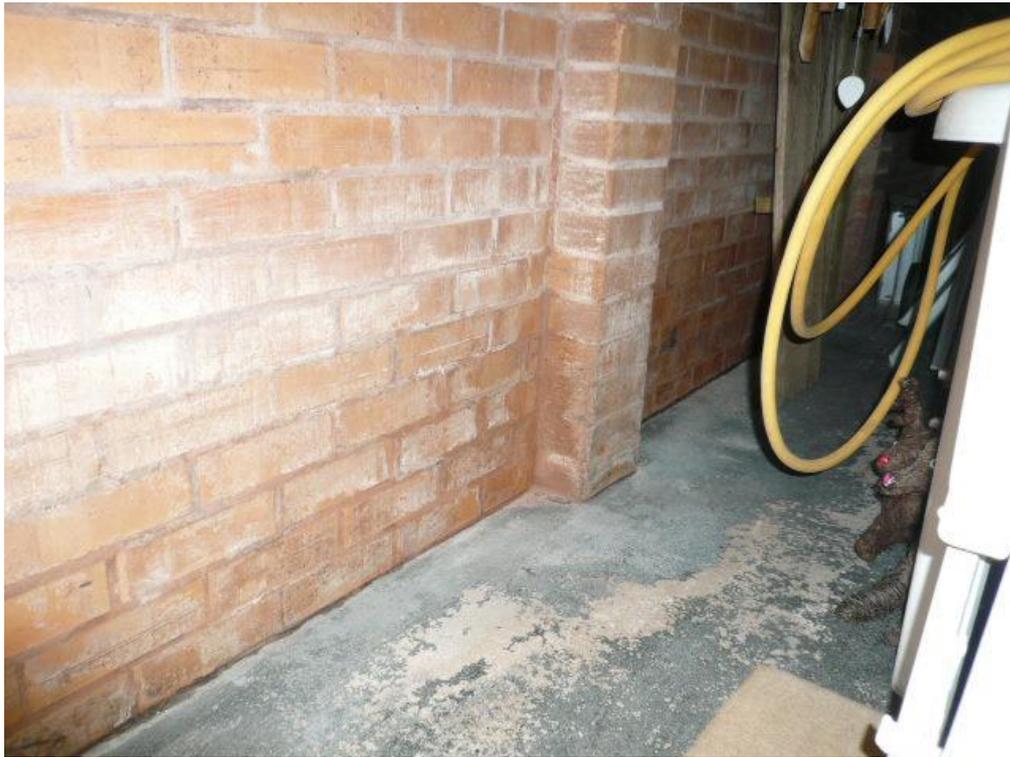
Photograph – 5. A general view of the brickwork in the garage at 19 Avenue showing it to be in good condition.
