S. Butler
Chartered Surveyor and Home Inspector
234 Derby Road, Chellaston, Derby, DE73 6RU
(01332 702225)

3rd November 2015

To investigate suspected decay of roof trusses at the above property.

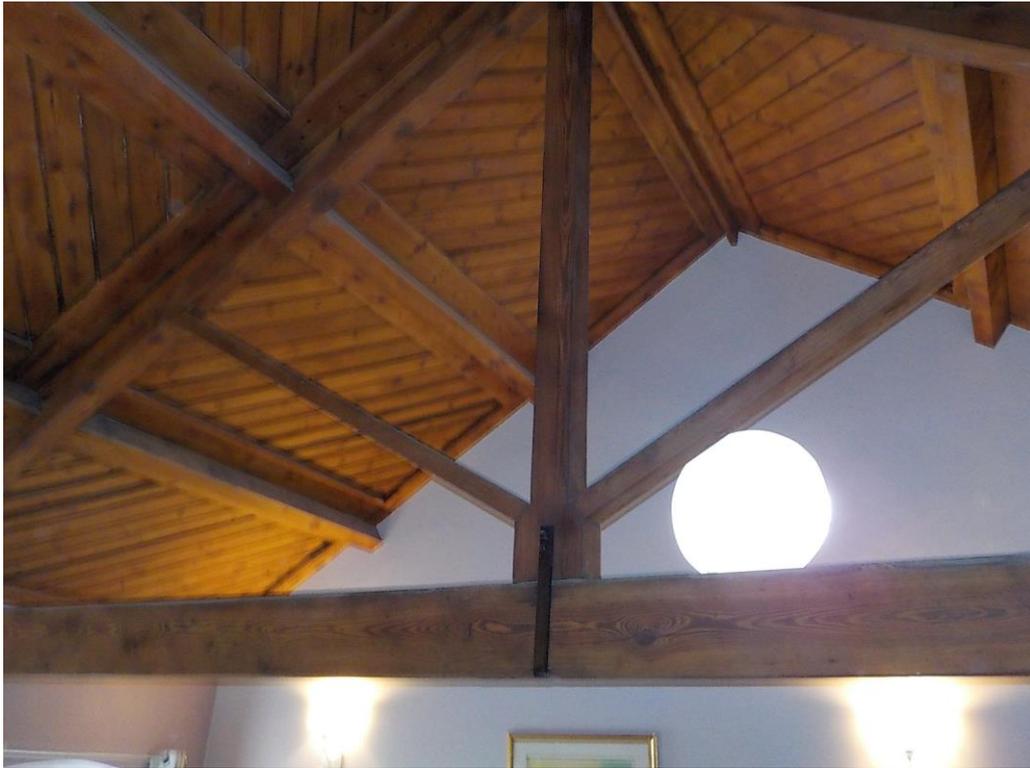
Photograph 1 shows the general arrangement of the truss.

1) General Layout of the roof structure

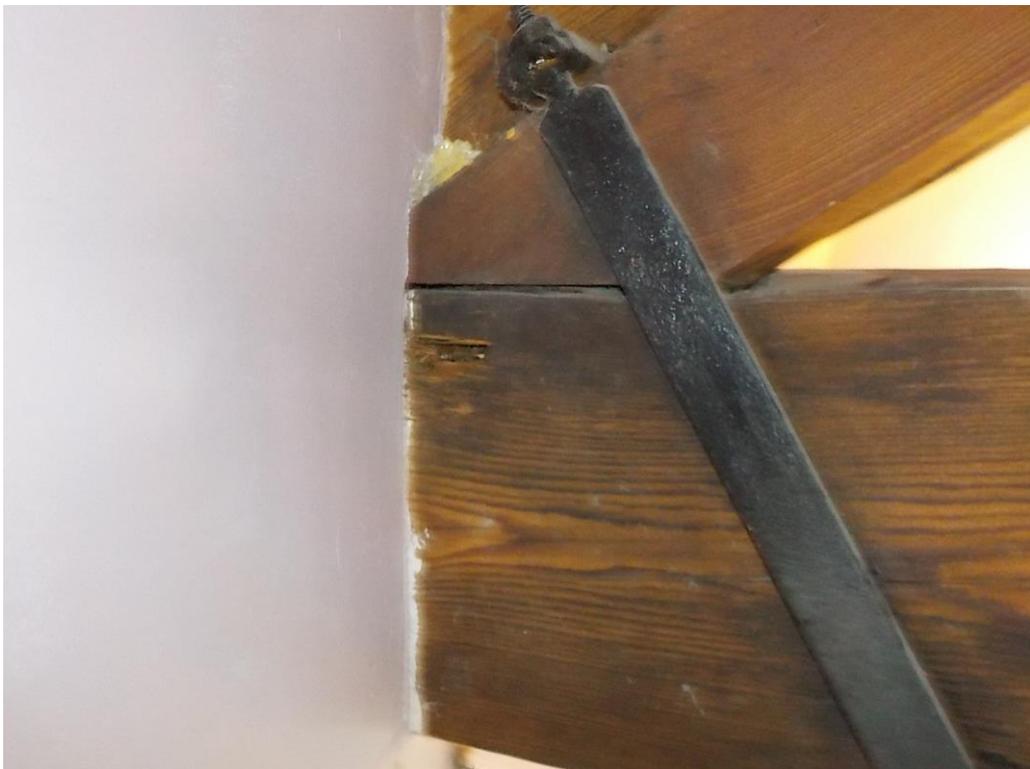
South West Bedroom – Horizontal Chord

The horizontal chord of the central truss has an area of decay close to the top of its east face immediately adjacent to its bearing into the south wall of the property. The decay affects a surface area of about three inches by two inches. The depth of the decay into the beam is not known. There is no reason to suspect the decayed area extends to the area of the beam that is concealed within the wall. The area of decay is shown at Photograph 2

The timber in the area of decay was dry at the time of inspection suggesting that the decay is historic

2) Approximately two inch by three inch area of decay on the horizontal chord immediately adjacent to the face of the wall.

Given the apparently small area of decay in relation to the size of the timber it is considered that the decayed area of wood can be chopped out and filled to match the existing face of the timber.

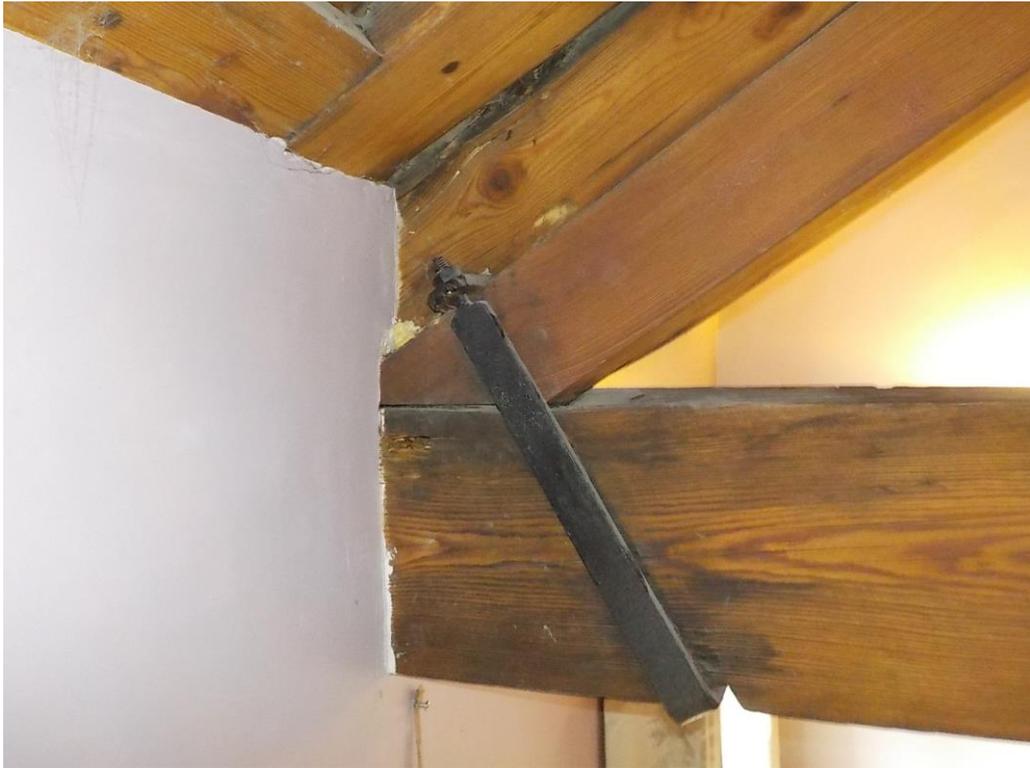
South West Bedroom – Diagonal Spacer

There is an approximately six inch by two inch area of decay along the top of the east face of the spacer at its top edge. The depth of the decay is not known. It is considered unlikely that the timber substantial penetrates the wall.

The timber in the area of decay was dry at the time of inspection suggesting that the decay is historic

- 3) Approximately 6 inch by two inch area of decay appearing black along the top of the diagonal spacer.

Given the small area of decay and that any load is likely to be in compression it is considered that the decayed area of wood can be chopped out and filled to match the existing face of the timber.

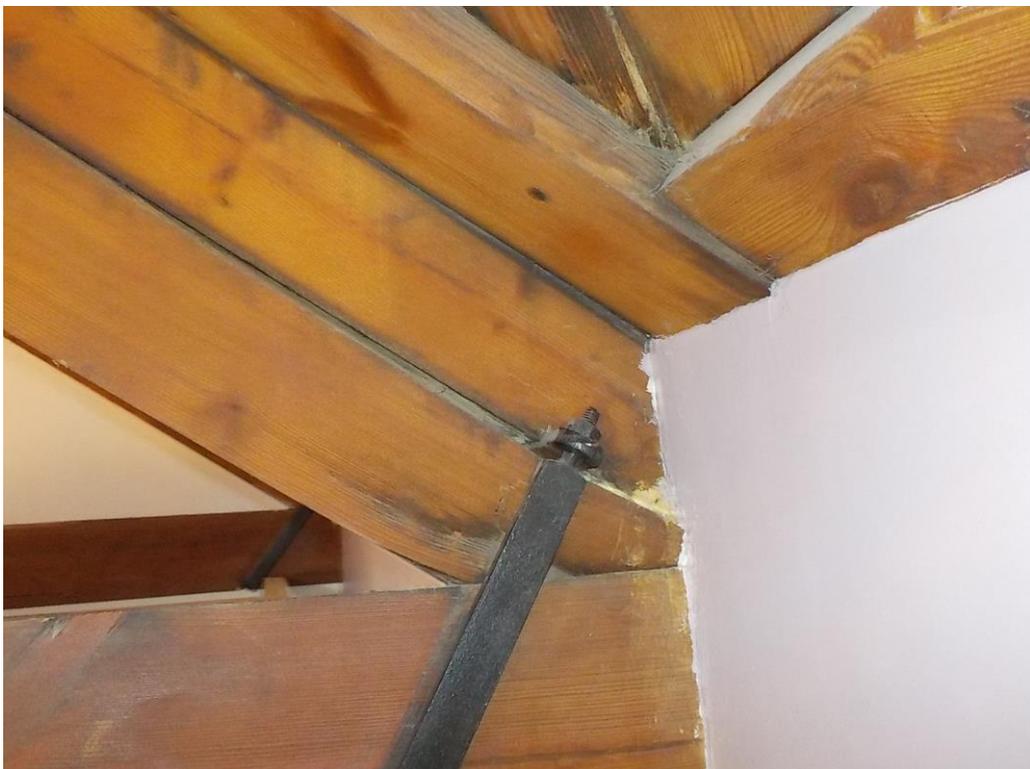
South West Bedroom – Diagonal Chord

The bottom of the chord has decayed where it sits on top of the horizontal chord. An area of about eight inches by three inches by two inches has decay on the bottom and west face of the chord as show by Photograph 4.

The timber in the area of decay was dry at the time of inspection suggesting that the decay is historic

- 4) Approximately eight inch by two inch by two inch area of decay on the bottom edge and face of then diagonal chord

It is considered that the chord can be repaired with a resin or combination of resin and splicing in new timber. As the bottom edge of the chord is likely to be in tension it is likely that any repair will require strengthening with metal pins similar to those shown on the attached sketch at Photograph 5. The chord may also require pinning to the horizontal chord if the area around the hidden fixing is found to be decayed as shown in Photograph 5.

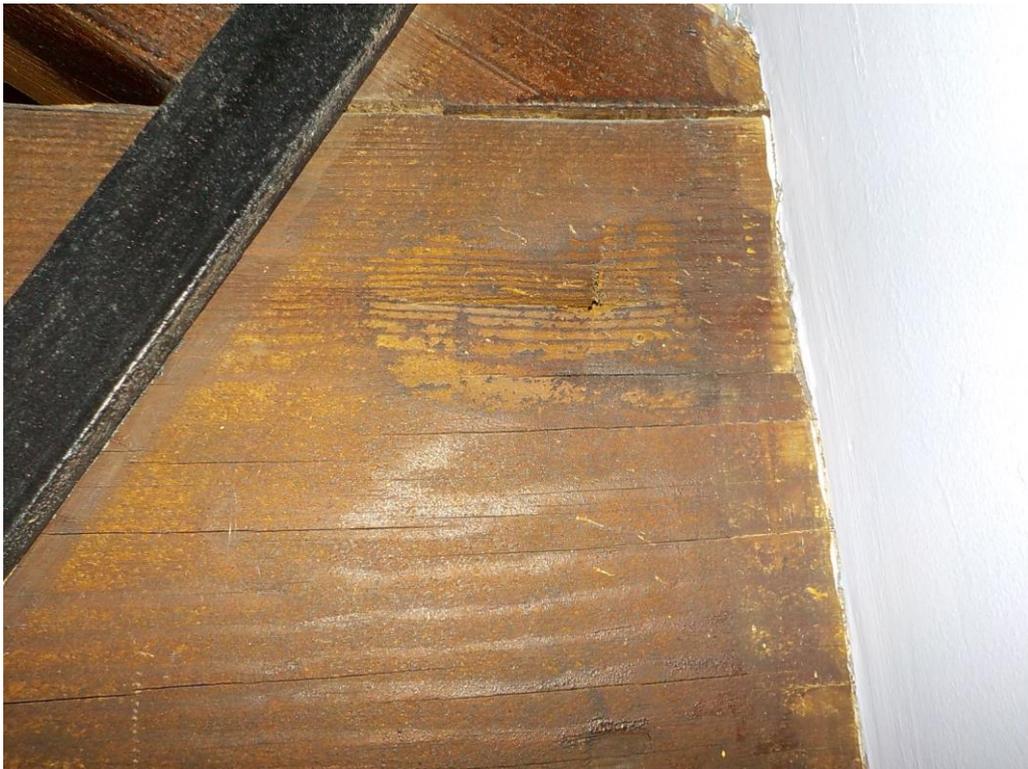
South East Bedroom – Horizontal Chord

The horizontal chord of the central truss has an area of decay on its east face. The decay affects a surface area of about one inch by two inches. The depth of the decay into the beam is not known but is believed to be superficial. The area of decay is shown at Photograph 6

The timber in the area of decay was dry at the time of inspection suggesting that the decay is historic

- 6) Small area of decay on the east face of the central truss in the south east bedroom.

Although the end of the Chord is in tension given the apparently small area of decay in relation to the size of the timber it is considered that the decayed area of wood can be chopped out and filled to match the existing face of the timber.
